JIRO KOMORI

A Glacial Lake Study and Recent Mountaineering Conditions in the Bhutan Himalaya

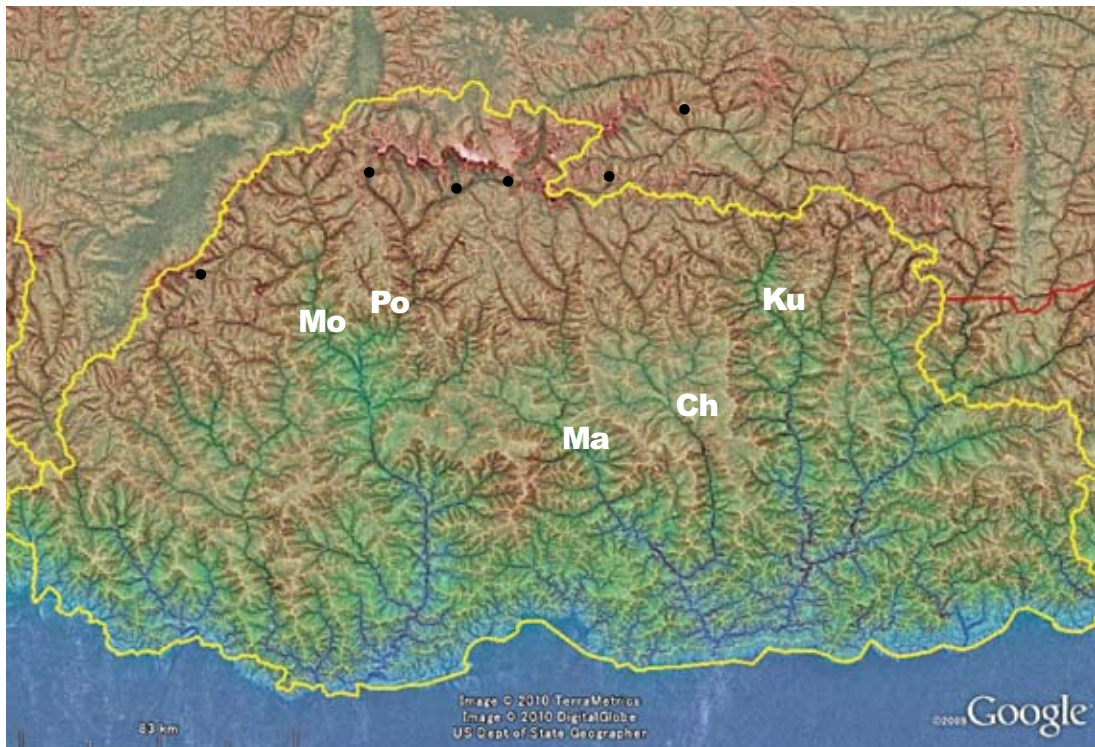
Fig. 1 Topographical map of Bhutan. The map was created by Mr. Tatsuro Chiba (Asia Air Survey Co., LTD.) on Google Earth using Red Relief Image Map method (RRIM, Chiba et al., 2008) with SRTM DEM. The map expresses regional difference in geomorphological condition, such as deep valley in the great Himalaya, dendritic valleys and erosion fronts in southern half of Bhutan. M: Mangde Chhu. C: Chamkhar Chhu. Solid circle: Outburst glacier lakes after the little ice age termination (see Table. 1).

The field surveyed area especially covers the headwaters of Mangde Chhu (Fig. 1, Photo. 1). The area lies along with most of eastern part of the snowman trek which is a one of the longest trekking route in the Himalayas. The field surveys were completed in the autumn 2009 and 2010, and have been

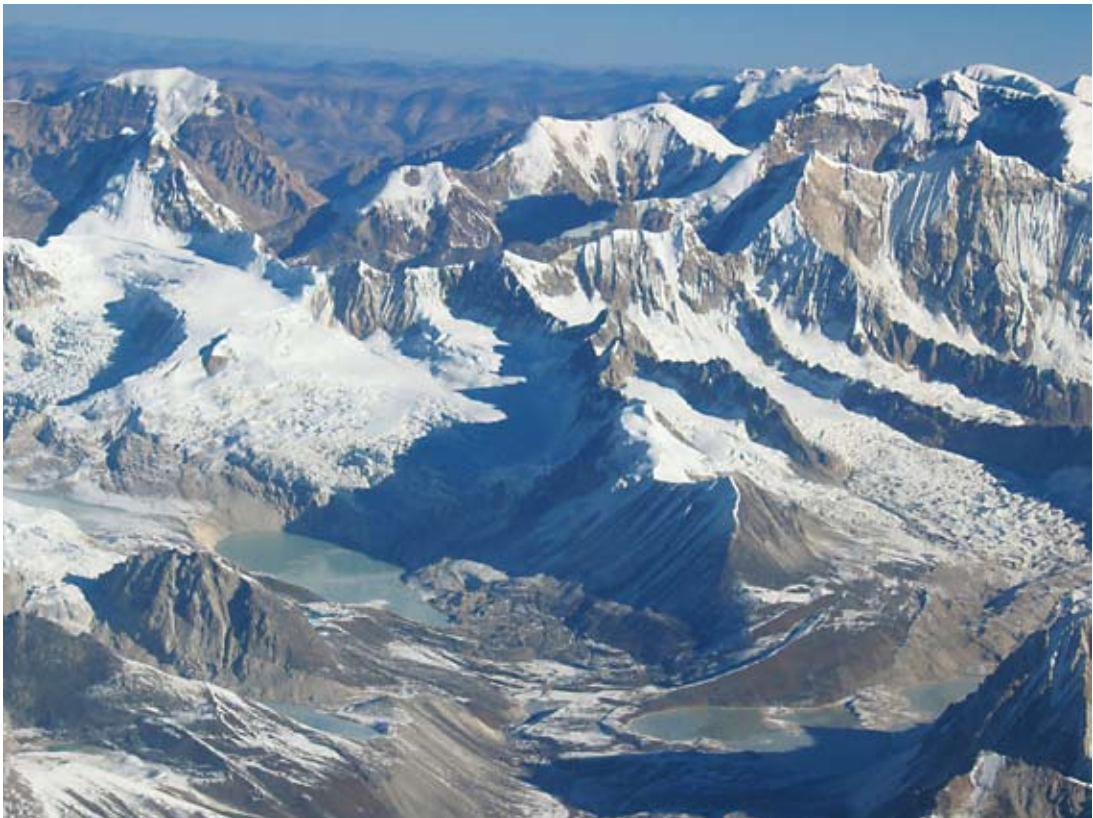
Photo. 1 Bird's eye view of the Mangde Chhu headwaters and Tibetan Plateau (back side). Glacial lakes in the near side of photo were surveyed in 2009 and 2010. Photo taken by Mr. Konagaya (Kawasaki Geological Engineering Co. Ltd.) from chartered Druk Air in 2002. High ridges from Gangkar Puensum is pictured right.

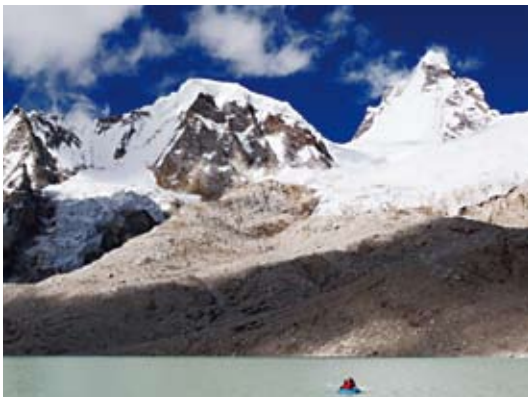
Photo. 2 Bathymetric survey in the Mangde Chhu headwaters. Photo taken in September 2010. The peak in the right back is Chumhari Kang

The bathymetries on the lakes were carried out by inflatable boat with depth-sounder function of a fish finder (Photo. 2 and 3). We have selected target lakes from the list of “potential dangerous lakes” in previous inventory in Mool et al., (2001), and vulnerable or risky lakes which were defined by remote sensing technic using satellite DEM data (Fujita, 2011. Advanced manuscript has been prepared). The archived bathymetric maps show that 1) in most cases, the deepest part lies at upper

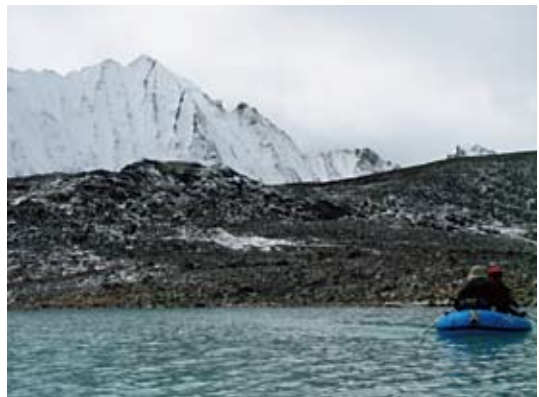
Photo. 3 Bathymetric survey in Tsholim lake, Pho Chhu headwaters. Photo taken in September 2010. The peak in the back is the western peak of Mt. Namshila, which was scaled by Chuba University in 1985.

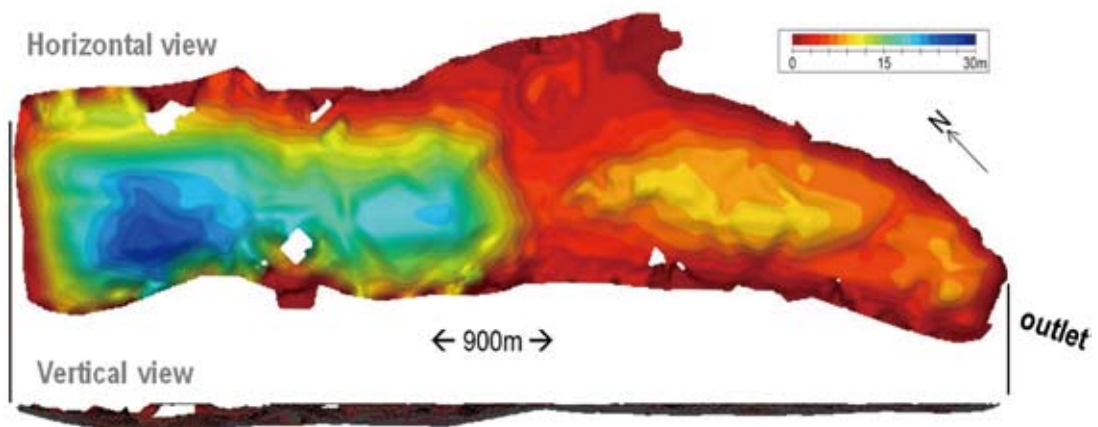
Fig. 2 Bathymetric map of a glacial lake in the Mangde Chhu head water (Zanam C) . Deepest part, -26 m was measured at the upper part (left in the figure). On the other hand, the lower half (right in the figure) shows relatively shallow -6 ~ 10 m. Instead of the usual ball shaped profile in a lot of peoples imagination and some web-sites , actual profiles in most of the glacial lakes shows very shallow.

part of the lake, 2) the lower part of the lake is 10 ~ 20 meters deep at the most, 3) some lakes have threshold sill(s) which are formed by submerged moraine near the lower part of the lake(Fig. 2). The flood analysis and hazard mapping will be considered at latter half of this project. In the light of these topographic characteristics, water discharge volume in case of the outburst flood can be estimated with more precision. The preliminary flood analyses show that the risks from GLOF are lower than originally expected in the Mangde Chhu basin (Koike, 2011).

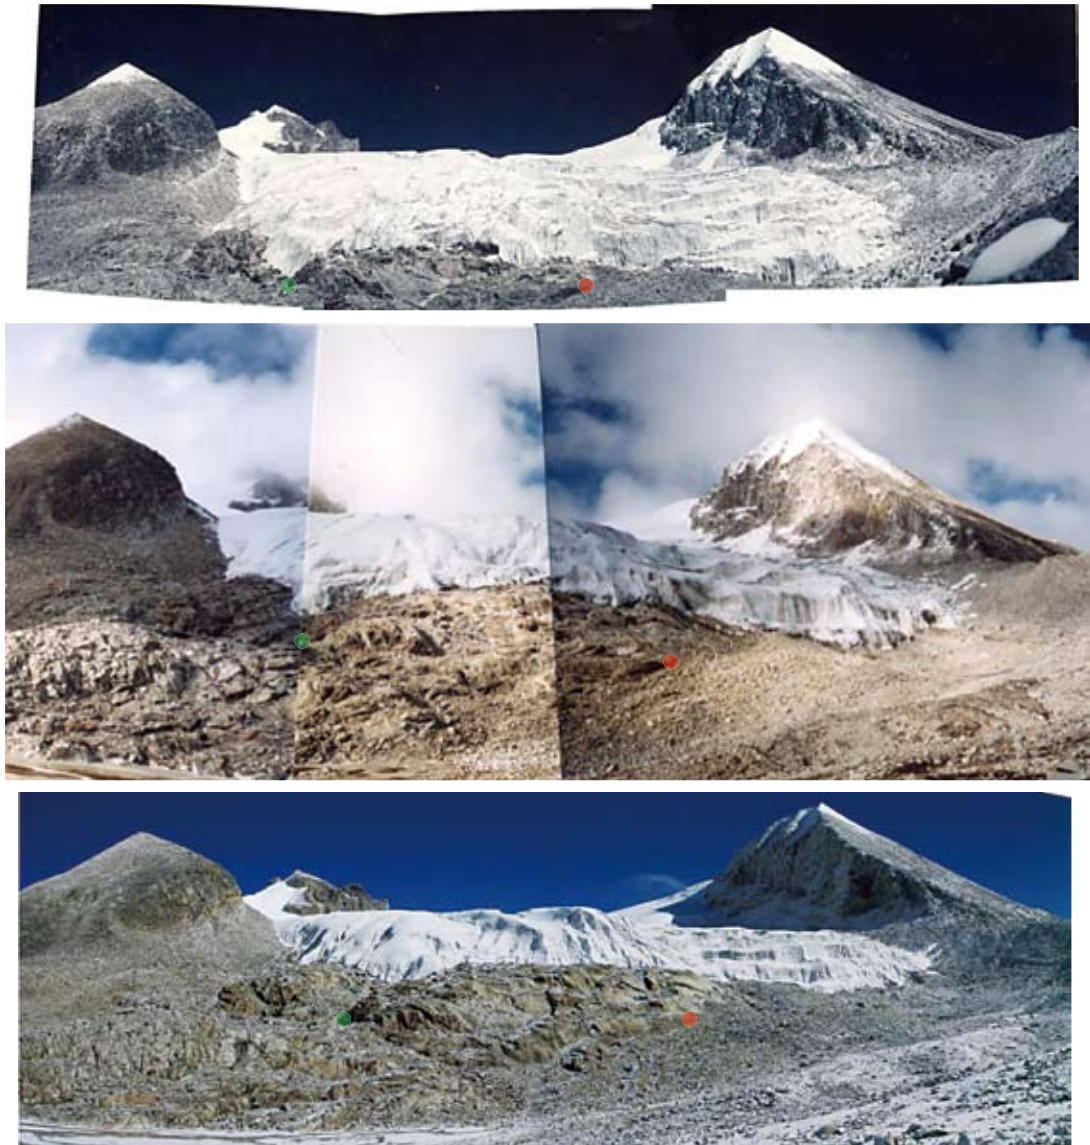
Photo. 4 Glacier ice variation since 1983 in southern Gophu La.(28.005° N, 90.300° E) Photo taken by Dr. Tsukihara in 1999, Dr. Naito in 1999 and this study in 2009. Green and red solid circle are corresponding points of each photographs.

photography” (Naito, 2003). In this project, we try to reacquire the photographs in 2009 and 2010. Comparing these photographs, it shows that the glaciers have been retreated sharply almost 40-60 meters since 1984 (Photo. 4). Detail estimation will be carried out using the photogrammetric analysis in this project.

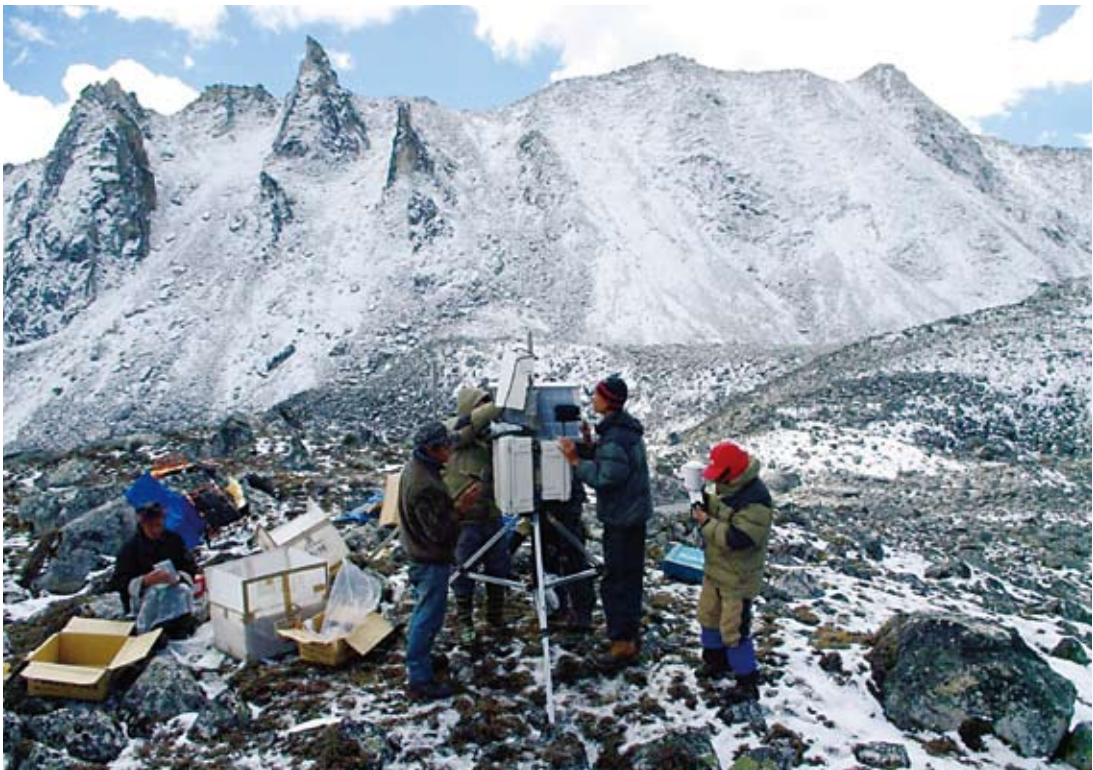
Photo. 5 Installation work of the automatic weather station on the moraine in September 2009 . The station had been keep stable condition except for the theft of tensioning wires by the local people. Lightly snow dusted ridge in the back in the photo is 5,500 ~ 5,400 m peaks (27.965° N, 90.335° E).

We established an AWS in the moraine dame of Zanam F Lake (EL. 5,230 m, N27 ° 58.23' , E90 ° 20.15'). Principal data observed from October 2009 to October 2010 is as follows; Annual mean air temperature: -3.5 ° C, Annual surface soil temperature: +0.7 ° C, Annual precipitation: 820.0 mm, Maximum and second maximum snow depth: 43.4 cm (30th, March) and 38 cm (8th, October). Latter

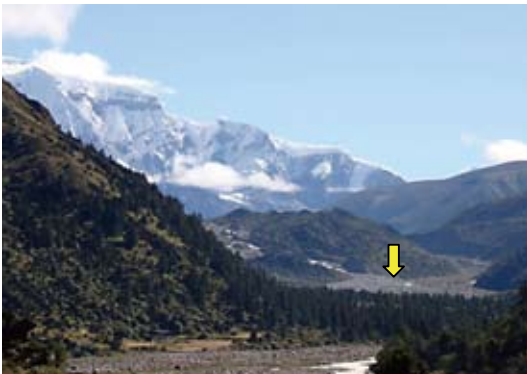
Photo. 6 Fan shaped deposition (yellow arrow) in the front of the terminal moraine. Table mountain is seen behind the moraine. Photo taken by Mr. Dowchu Drukpa (DGM) in September 2009.

- 1) Debris fan is remained in the front of terminal moraine (Photo. 6).
- 2) There are many debris lobes which consist of well sorted sand and gravel.
- 3) The lobes overtop the bank of the channel and bush as well as river mouth of Gotey Chhu.
- 4) Upper sources of the lobes and channel are abruptly disrupted.
- 5) Small sand/gravel mound remain at upper end in the channel (Photo. 7).

The characteristic 1, 2 and 3 proves that some debris flow occurred on the glacier, 4 and 5 shows that debris flow originated from intra-glacier as the sand/gravel fountain, respectively. In other words, flood water with large quantity of debris was transported from upper stream via intra-glacier channel (Fig. 3). However our field survey found out fresh empty pond at the upper stream on the glacier (Photo. 8). The estimated volume of the empty lake pond is not enough to discharge the estimated volume of the water at down stream. We could not obtain reliable evidence of the source of the flood water. After the field survey, remote sensing analysis using straddled satellite data by Dr. Yamanokuchi, Remote Sensing Technology Center of Japan, shows abrupt disappearance of a supraglacial lake at 5.5 km upstream from the outlet (Yamanokuchi et al., 2011). A Vanished lake is strong evidence of a small GLOF event which was a source of the water and sand/debris fountain and flow near the outlet.

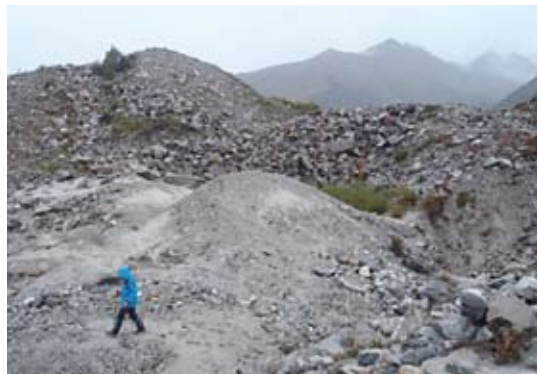
Photo. 7 Sand and gravel mound at the far end of the debris flow channel. In contrast to the mound, a vent also remains with a small amount of water (right).

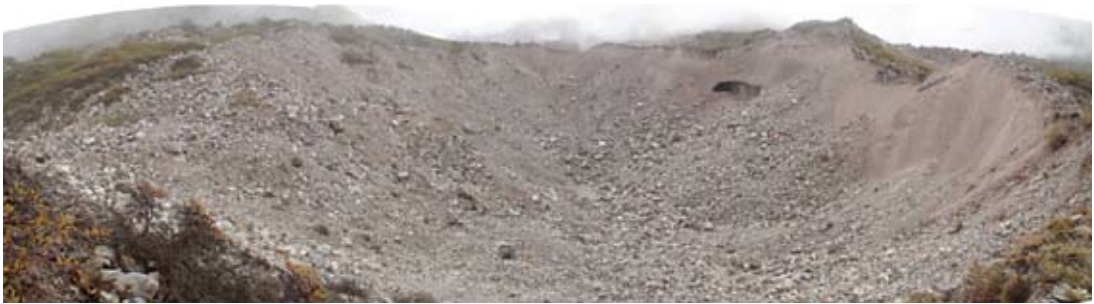
Photo. 8 A dried up depression and intra-glacial channel (back right) on the lower part of Tshojo Glacier. Glacial ices are exposed on the northwest ward of depression wall.

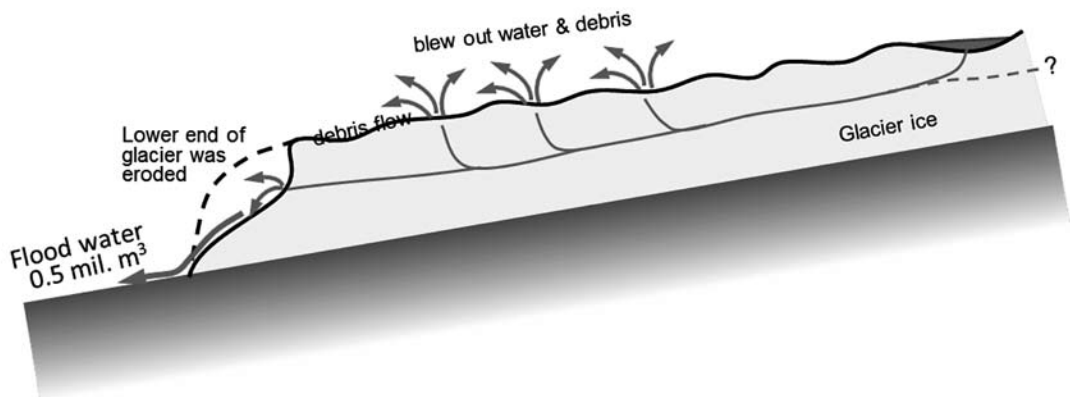
Fig. 3 Schematic profile of Tshojo outburst event in 2009. Horizontal to vertical ratio is not real. Thickness of the glacier ice was elongated.

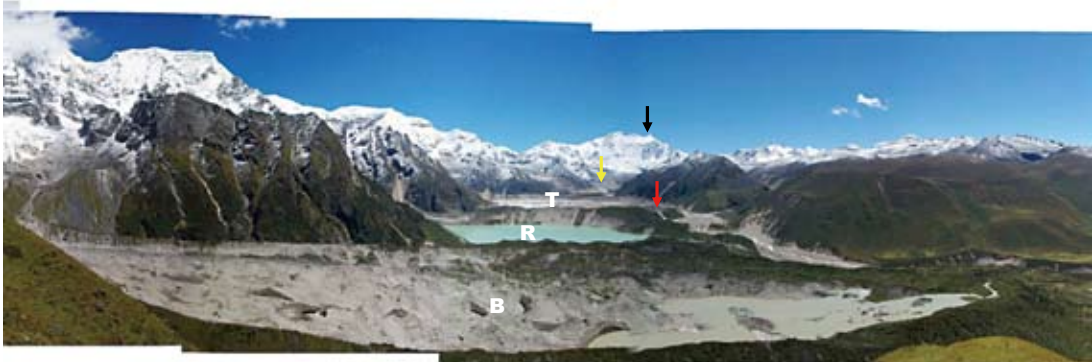
Photo. 9 Glacial lake complex in Lunana. B: Bechung glacier. R: Raphstreng glacier (completely changed into a green colored glacial lake). T: Thorthormi glacier. Yellow arrow: Luggye glacier. Red arrow: Mitigation works site by UNDP GEF project (Photo. 10). Black arrow: Mt. Gangkar Puensum. Most foreside is hidden by Mt. Chumhari Kang (Photo. 2). Left ridge in the photo is the peaks leading out of the table mountain. Photo taken in September 2009 from 28.105° N, 90.222° E)

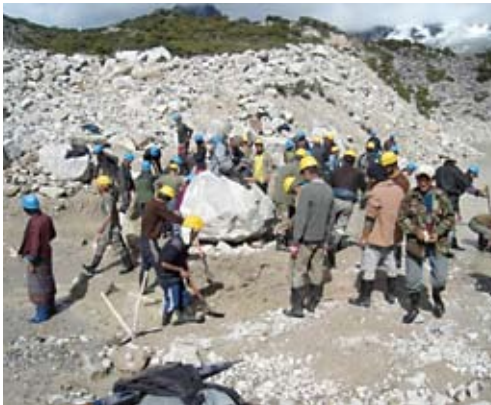
Photo. 10 GLOF hazard mitigation works in Thorthormi Tsho, Lunana. Photo taken by Mr. Karma Toeb (DGM).

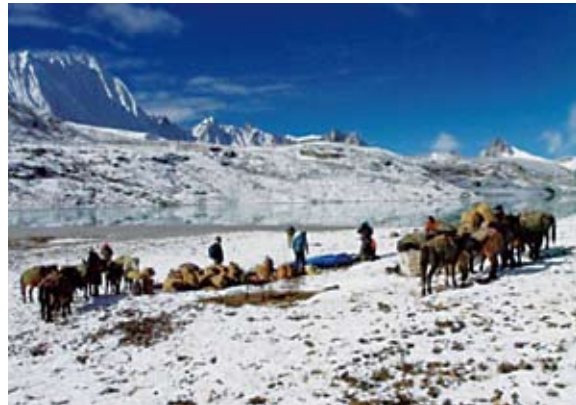
Photo. 11 Packing and loading in the first morning of the post monsoon. Equipment transportations were depended on horses on the snow and over 5,000 meters high. Photo taken in September 2010. Left peak in the photo is Mt. Namshila (Photo. 3).

As for the transportation, unlike the trekking in Nepal, each 25 kg of two packs are carried by horses and/or yaks. According to recent information, the horseman and Yak herder charge around 800 Ngultrum per a house/yak in Gasa, Laya and Bhumtang, and around 500 Ngultrum in Paro. The animal hiring price unfortunately has been increased caused by local economic inflation due to the employment growth by the lake drainage project in UNDP (Photo. 9 and 10) and trade boom of local specialty Cordyceps. Especially, recent babble economy in Laya and Lunana, and a shortage of successors in mountain villages have made very difficult to yak hiring (Photo. 11).

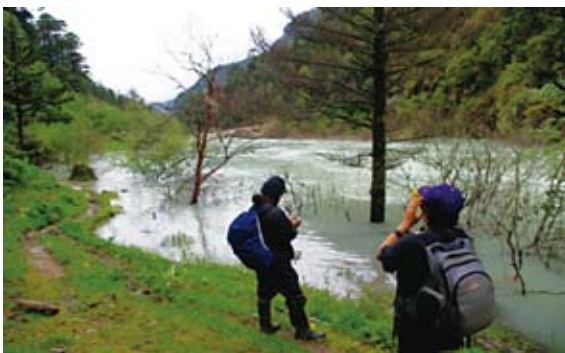
Photo. 12 A landslide dam in Chamkhar Chhu. Debris flow from the right bank dammed up the main river. Photo taken in July 2010.

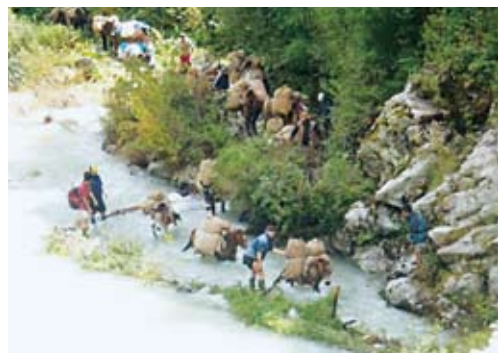
Photo. 13 Unintended repair work and risky pass along the stream due to the washing out of river bank. Original route was existed on the outcrop (right). Photo taken the early September 2010 in the south of Gasa.

In May, 2009 the rain storm in a couple of days from Cyclone Aila caused Bhutanese worst meteorological disaster. The storm devastated especially rivers in the central and west Bhutan. After the storm, trekking route near the rivers and gullies became prone to be washed away from a bit of swollen stream and rain fall. Our field work in September and October 2010 along the snowman trek needed to request for reconstruction of a bridge to Gasa Dzongkhag and was hung up few days due to minor repair works on the route by ourselves. We also found around ten natural dammed lakes along Chamkhar Chhu which were created by huge amount of debris from tributary valley during the storm (Photo. 12). Some of the trekking routes submerge under the natural dammed lake. Hence advance confirmation of route condition, minor repairing along the way and climb up a detour will be required for the next few years (Photo. 13).
